## Case Study: Resolving N2 Bus (RS-485) Issues on an existing S4 Open: BACnet-N2 Router installation.

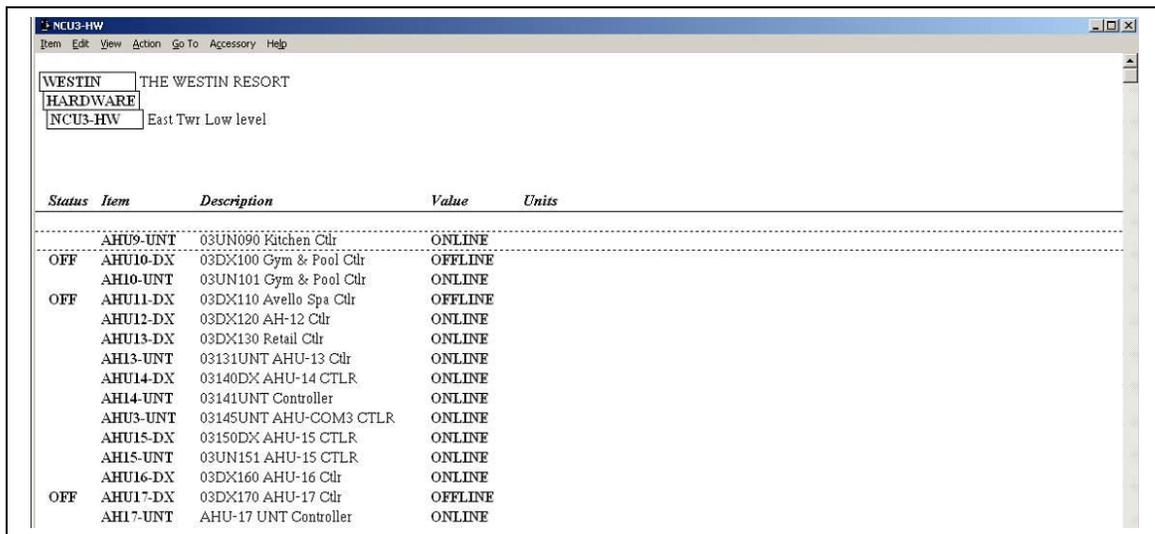
1. On the four installed S4 systems, the status reported whether the N2 devices were online/offline by the toggling of the NAE. The devices would randomly go offline for up to 20 minutes before toggling back online. One could not predict which devices would be the next to toggle their state.
2. Moreover, when a device was offline, attempts by the NAE controller to send commands/schedules and set points failed.

Status	Item	Description	Value	Units
	AHU9-UNT	03UN090 Kitchen Ctr	ONLINE	
OFF	AHU10-DX	03DX100 Gym & Pool Ctr	OFFLINE	
	AHU10-UNT	03UN101 Gym & Pool Ctr	ONLINE	
OFF	AHU11-DX	03DX110 Avello Spa Ctr	OFFLINE	
	AHU12-DX	03DX120 AH-12 Ctr	ONLINE	
	AHU13-DX	03DX130 Retail Ctr	ONLINE	
	AHU13-UNT	03131UNT AHU-13 Ctr	ONLINE	
	AHU14-DX	03140DX AHU-14 CTRL	ONLINE	
	AHU14-UNT	03141UNT Controller	ONLINE	
	AHU3-UNT	03145UNT AHU-COM3 CTRL	ONLINE	
	AHU15-DX	03150DX AHU-15 CTRL	ONLINE	
	AHU15-UNT	03UN151 AHU-15 CTRL	ONLINE	
	AHU16-DX	03DX160 AHU-16 Ctr	ONLINE	
OFF	AHU17-DX	03DX170 AHU-17 Ctr	OFFLINE	
	AHU17-UNT	AHU-17 UNT Controller	ONLINE

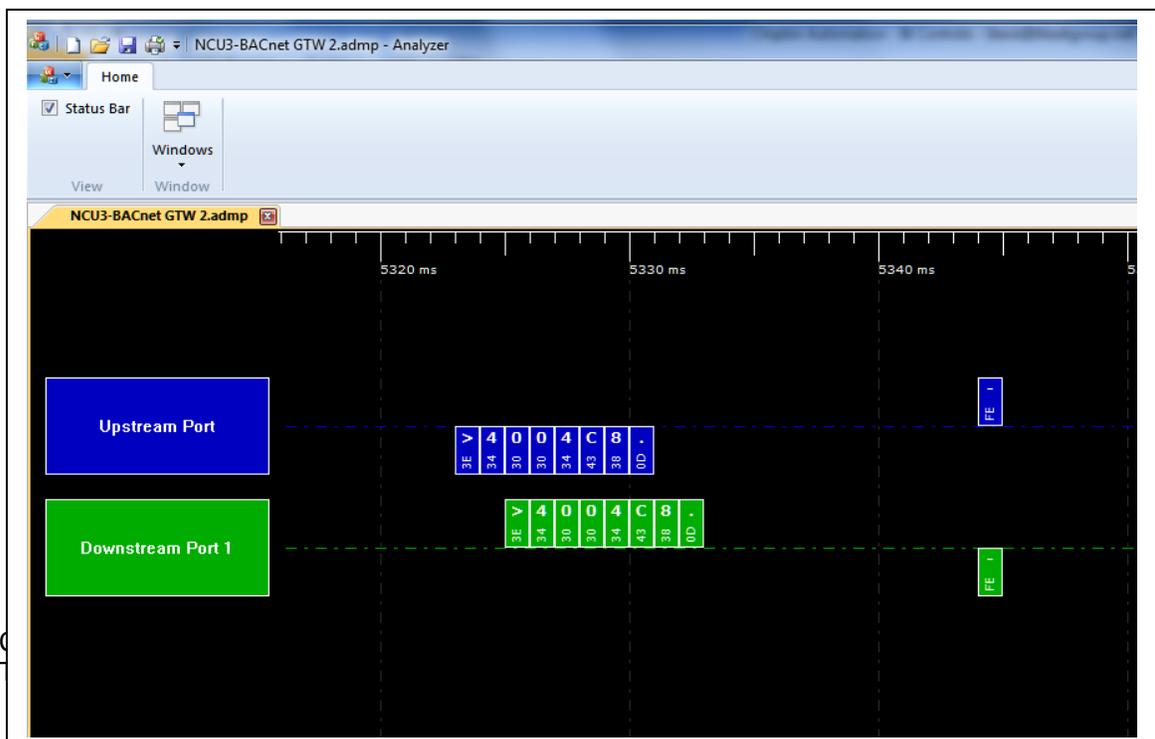
Looking at the image above of a COS poll request for the device at 0x40, we can see the N2 transaction starts with a >. The response that follows is invalid as it should start with either A (Ack) or N (Nak). A single character A is acceptable in this case; however, that is not what we are seeing. This could be garbling on the line, it could be an invalid response being generated from this address, it could be another device responding when it shouldn't and stepping on the A (simple one character Ack) response, or it could be a spurious response from another device.

Based on everything else that we saw, we think this started out as a valid response and became garbled due to N2 bus quality problems.

As we see, there is a long delay on the bus while the NCM is waiting for the proper response. In essence, it never happens. Then we see the NCM trying again and getting a valid response.

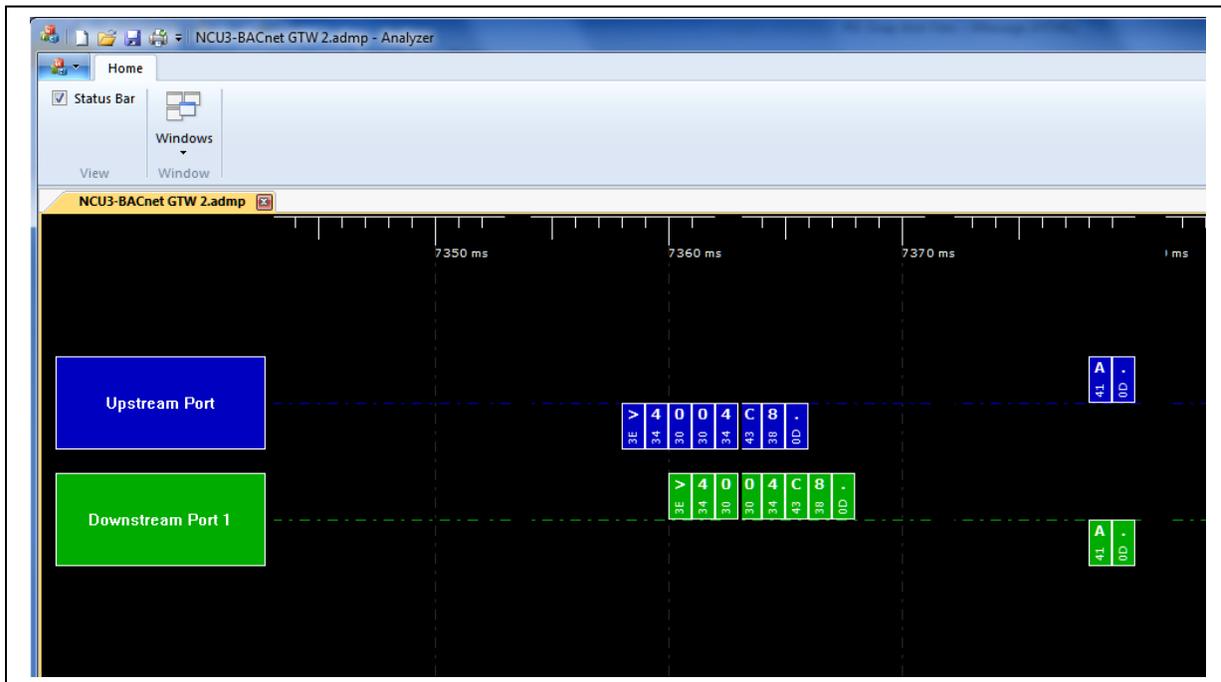
In general, what we are seeing is a completely normal operation of the N2 router, it is:

- Passing transactions from the NCM to the N2 bus and routing the responses back.
- Trying to bring offline devices back on line. There have been both successful and unsuccessful attempts at this.

- Most of the time we see successful point level transactions or COS polls at the device level. In a few cases we have observed timeouts where the N2 Router is waiting for an N2 device to respond which it never does.

We didn't see any completely **spurious communications** on the bus so we don't think that there was a **rogue device** responding when it shouldn't. Everything we saw in the snapshots reinforces what we saw when looking at the stats. You have a N2 bus that is not operating properly and the next step is to diagnose why.

For our client, the problem was resolved by isolating the section of trunk which contained the faulty device. It was noted that the section of trunk ran through a building area that had flooded as the seasons changed and that the flood had damaged the device: a faulty DX9100. Once we detected the faulty device, the recommended solution was two-fold depending on the customers' needs:

- 1) The interim solution: to power-down the DX9100. In this instance, removing the faulty device to temporarily run the system without it. This is a solution of sorts, but not a permanent solution.
- 2) The long term solution: replace it. By simply replacing the faulty device, the system would return working as intended.
