## Case Study: Resolving N2 Bus (RS-485) Issues on an existing S4 Open: BACnet-N2 Router installation.

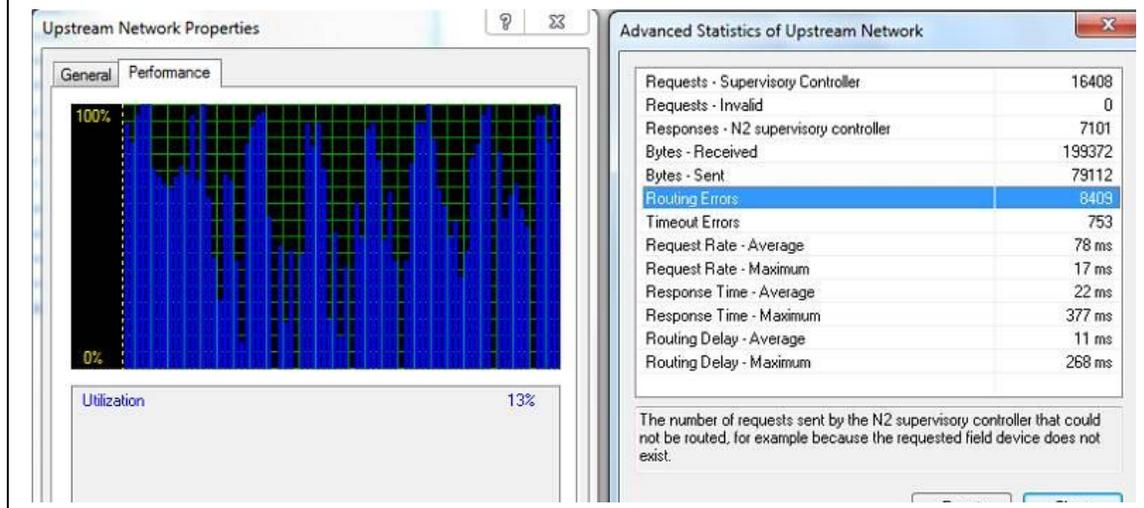
*Recently, a large number of timeouts and routing errors on our Metasys system have alerted us to a problem. The spare capacity on the upstream network shows that the Metasys controller is leaving the S4 router space to blend in messages on the trunk for the purposes of the BACnet interface.*
